Site Accessibility Evaluation

ABC Printing

**1090 S Milpitas Blvd
Milpitas, CA 95035**

CASp Evaluation

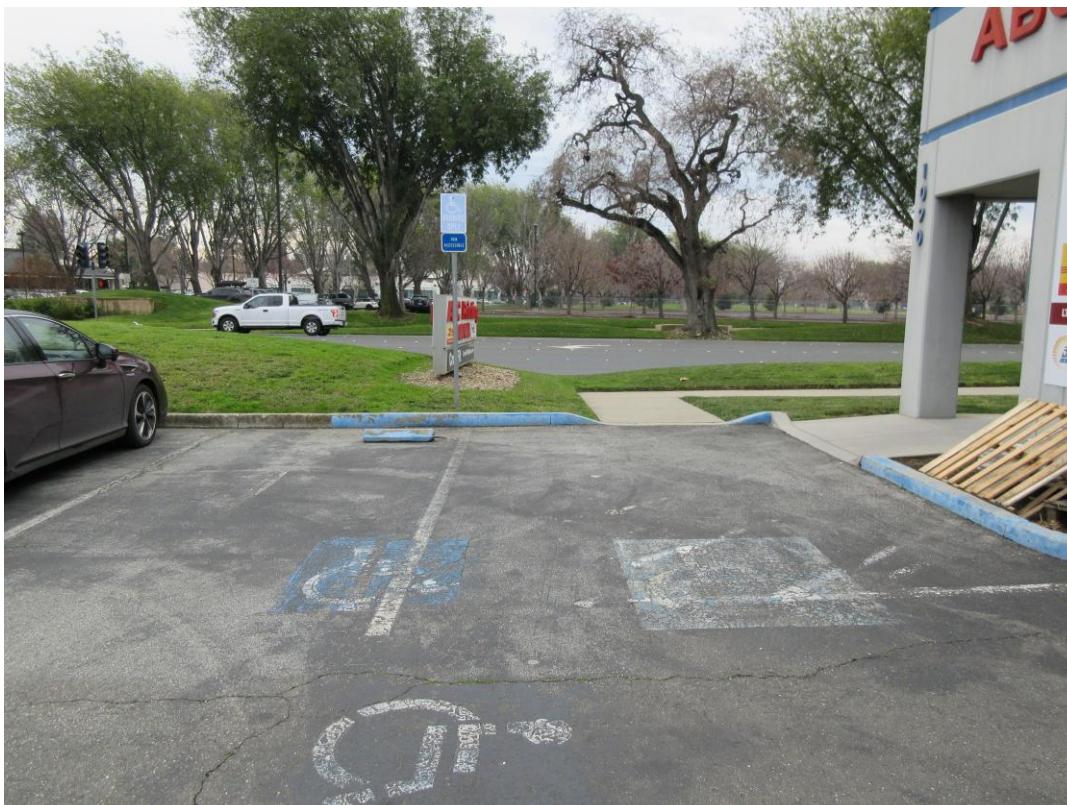
Finding: 1

The striping and markings for the accessible parking stall, loading/unloading access aisle are dilapidated and in need of repair and/or maintenance.

The slope of the parking space and access aisle were found to be in compliance.
